Observational Study of Final Cleaning and AHERA (Asbestos Hazard Emergency Response Act) Clearance Sampling at Asbestos-Abatement Sites in New Jersey

PEI Associates, Inc., Cincinnati, OH

Environmental Protection Agency, Cincinnati, OH

Aug 89

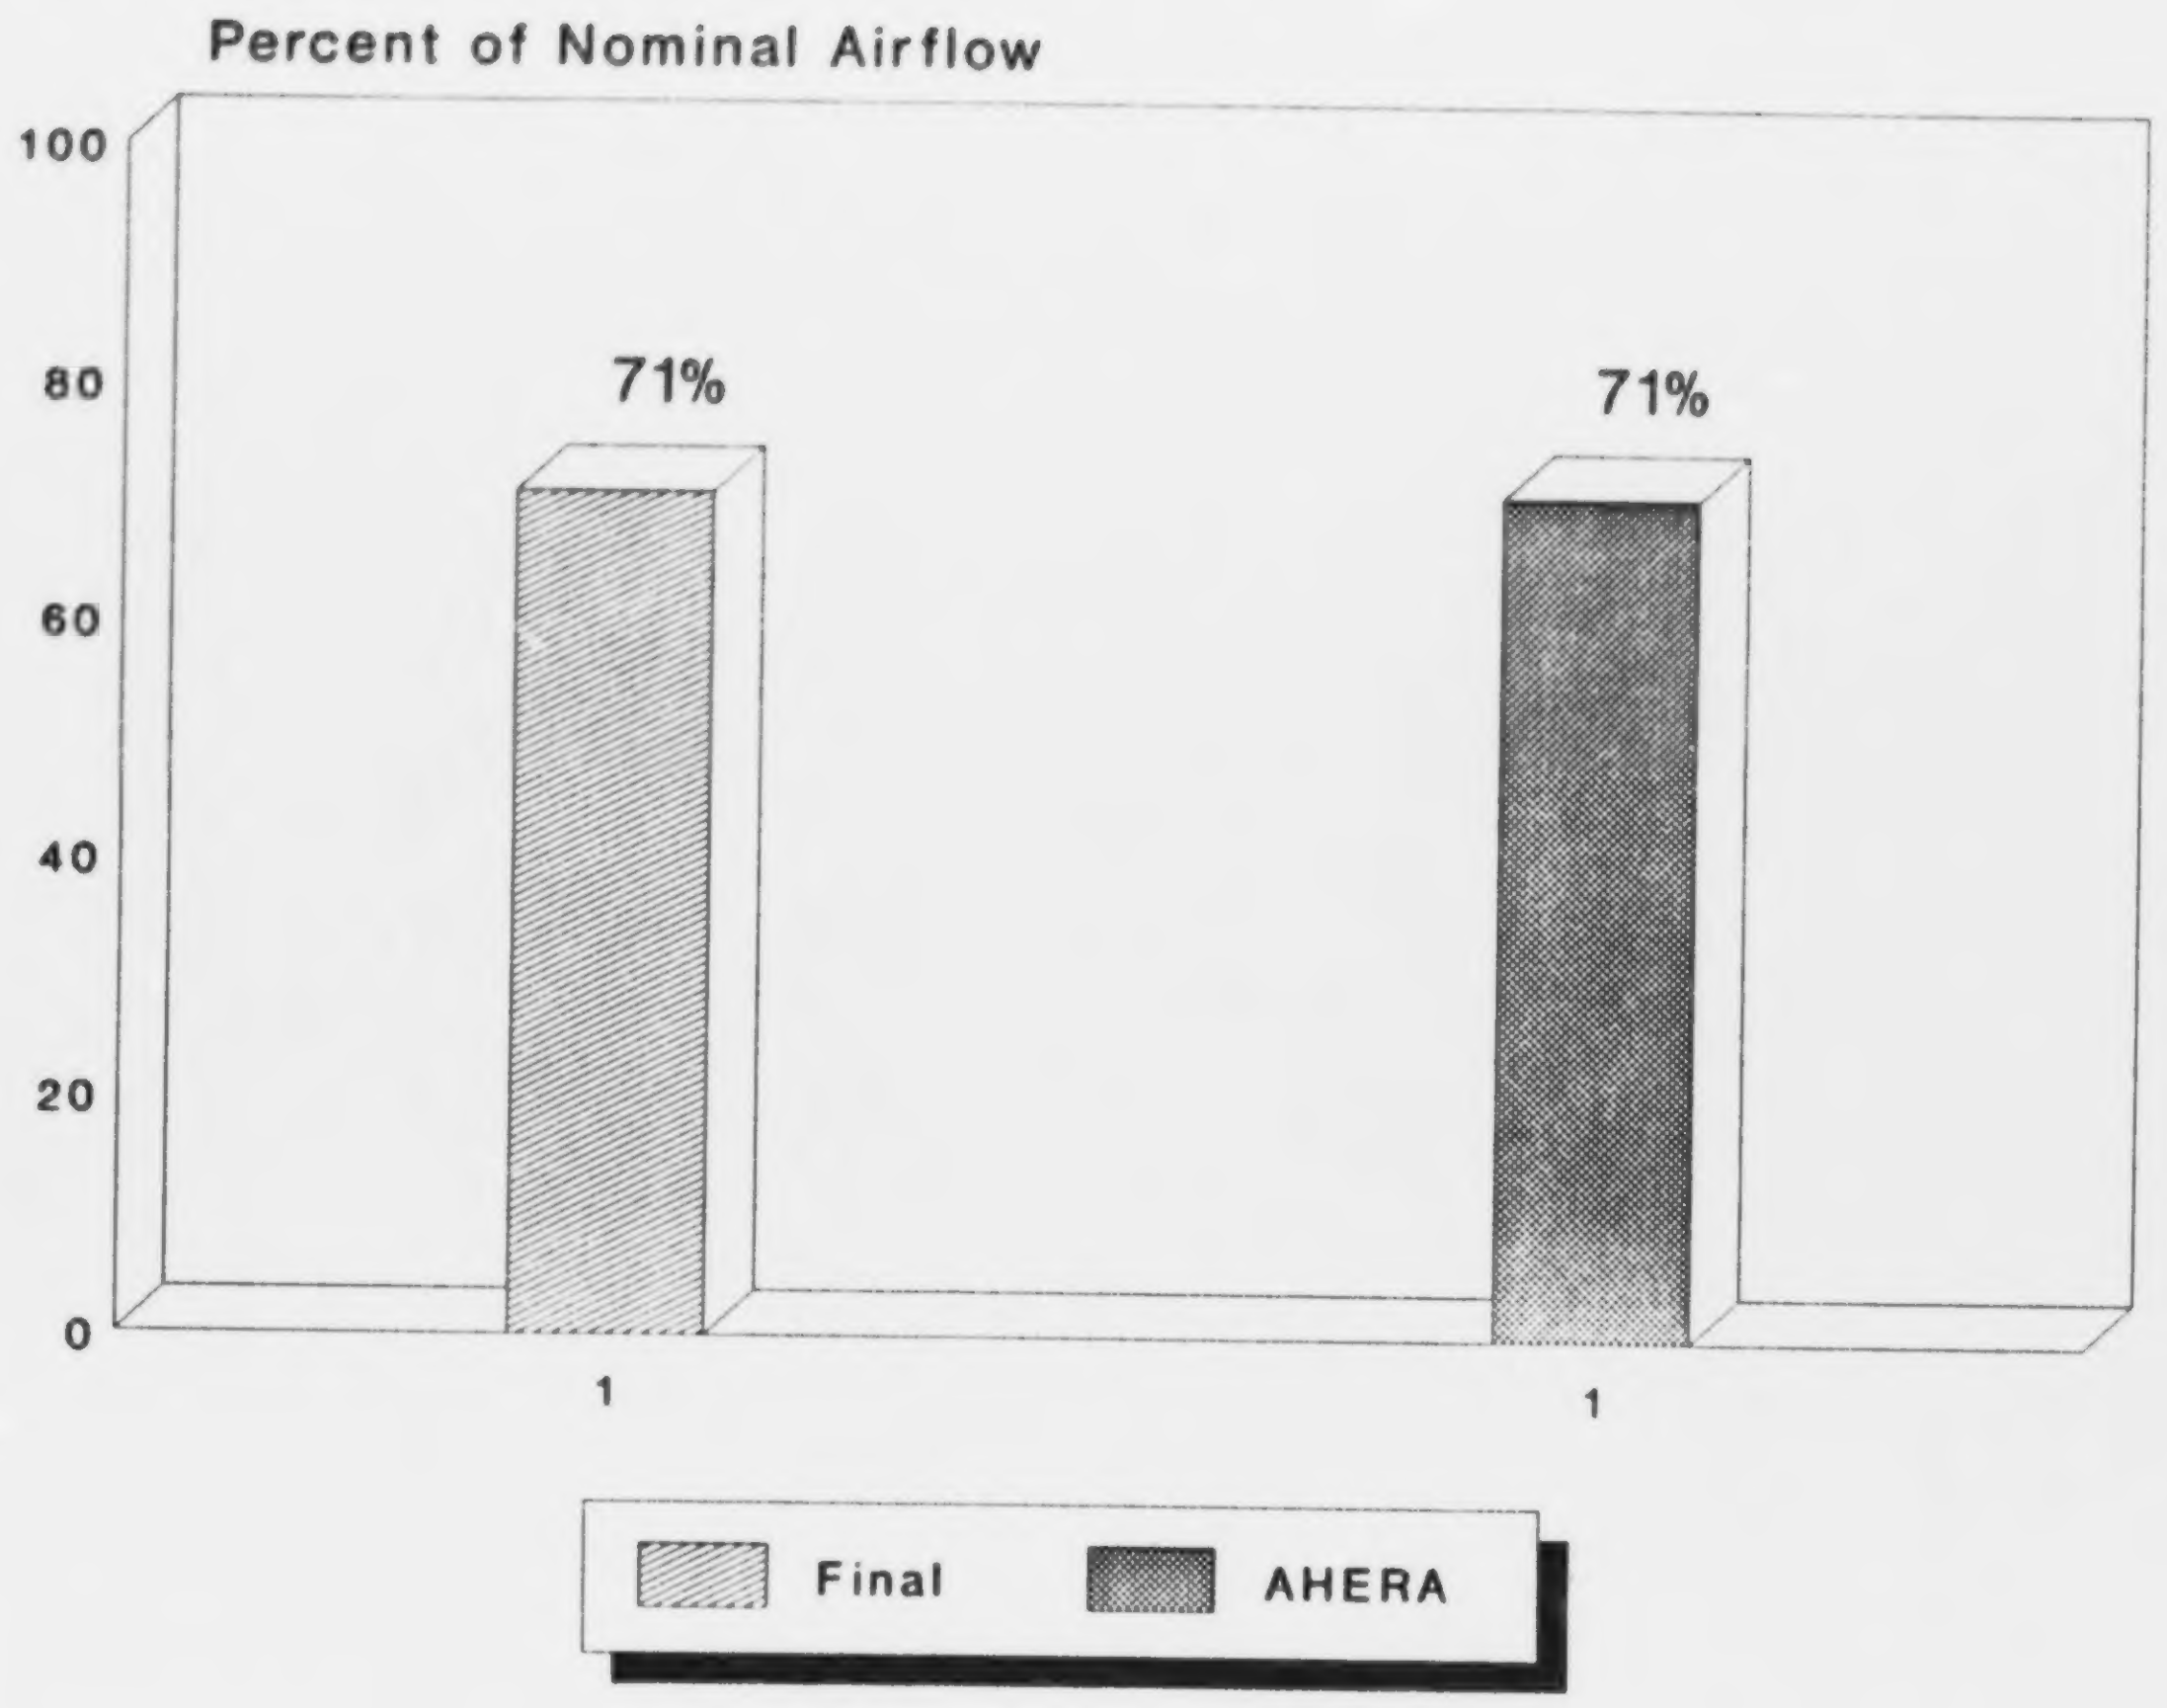
Figure F-1. Airflow performance for HEPA filtration systems operating during final cleanup and AHERA clearance.

Figure F-1 compares the measured air-intake volume for each HEPA-filtration unit operating during final cleaning and AHERA clearance sampling, with the unit's nominal air flow.

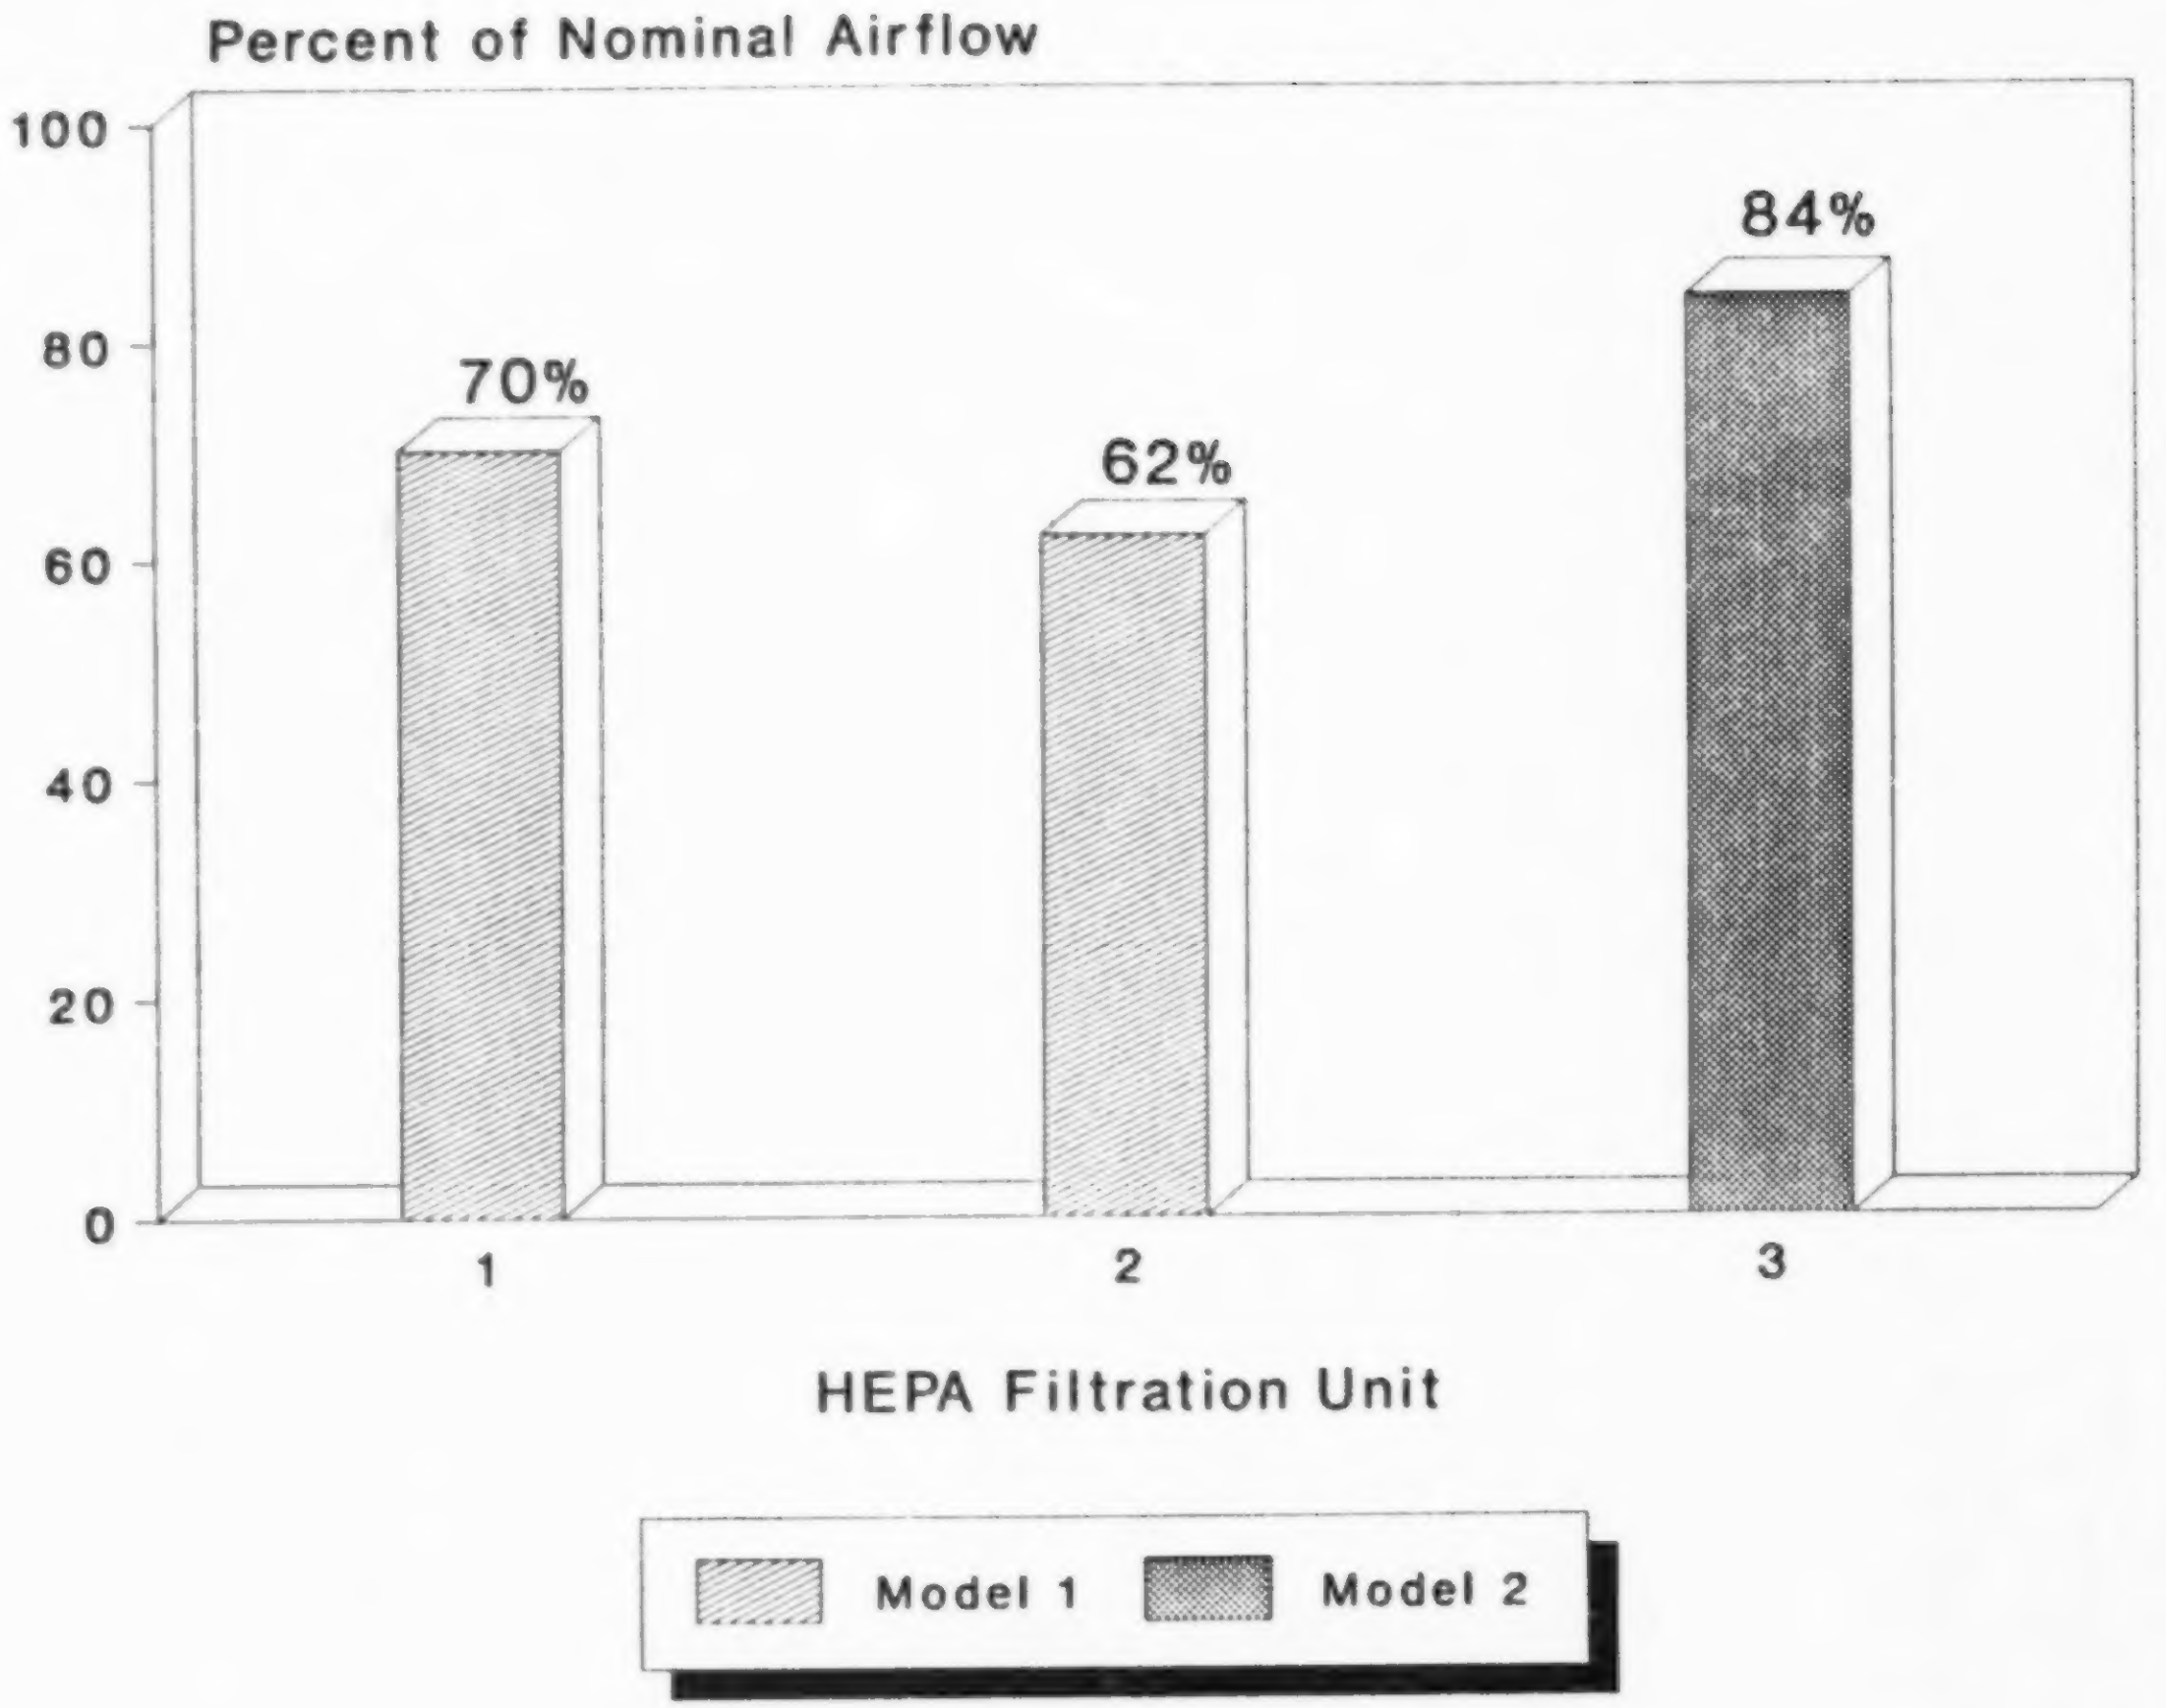
Figure Q-2. Airflow performance for HEPA filtration systems operating during AHERA clearance.

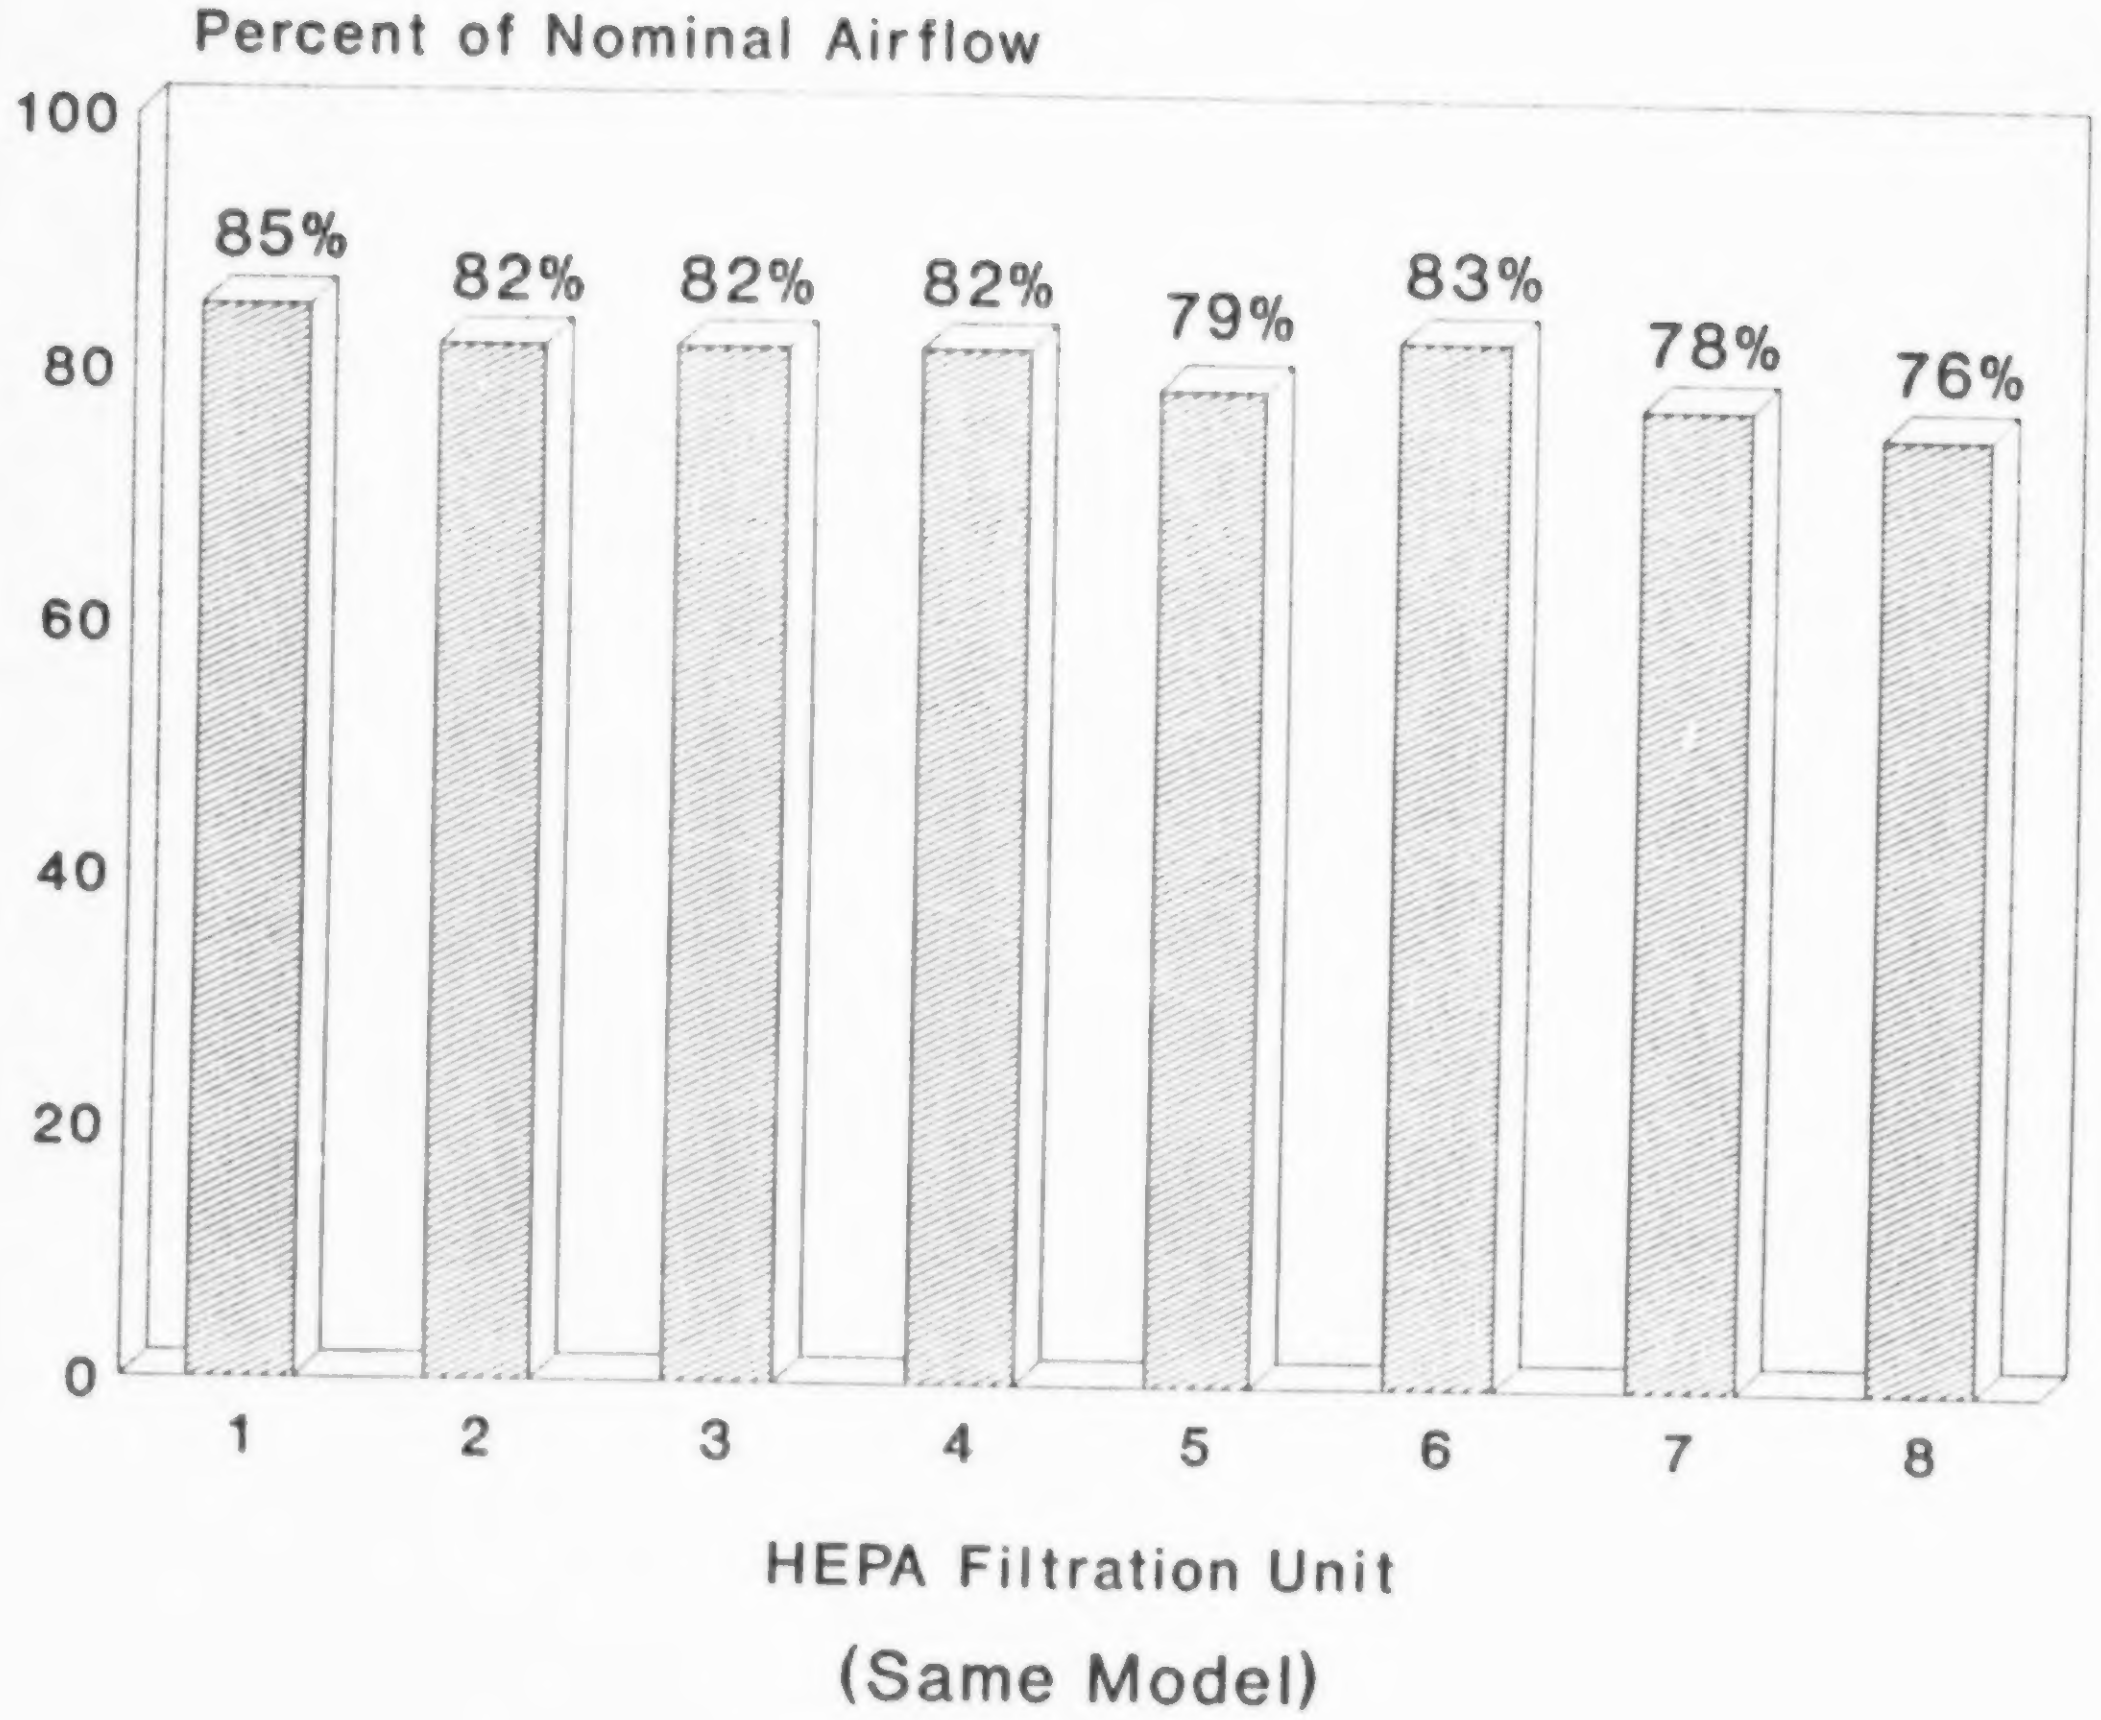
Figure R-1. Airflow performance for HEPA filtration systems operating during final cleanup.

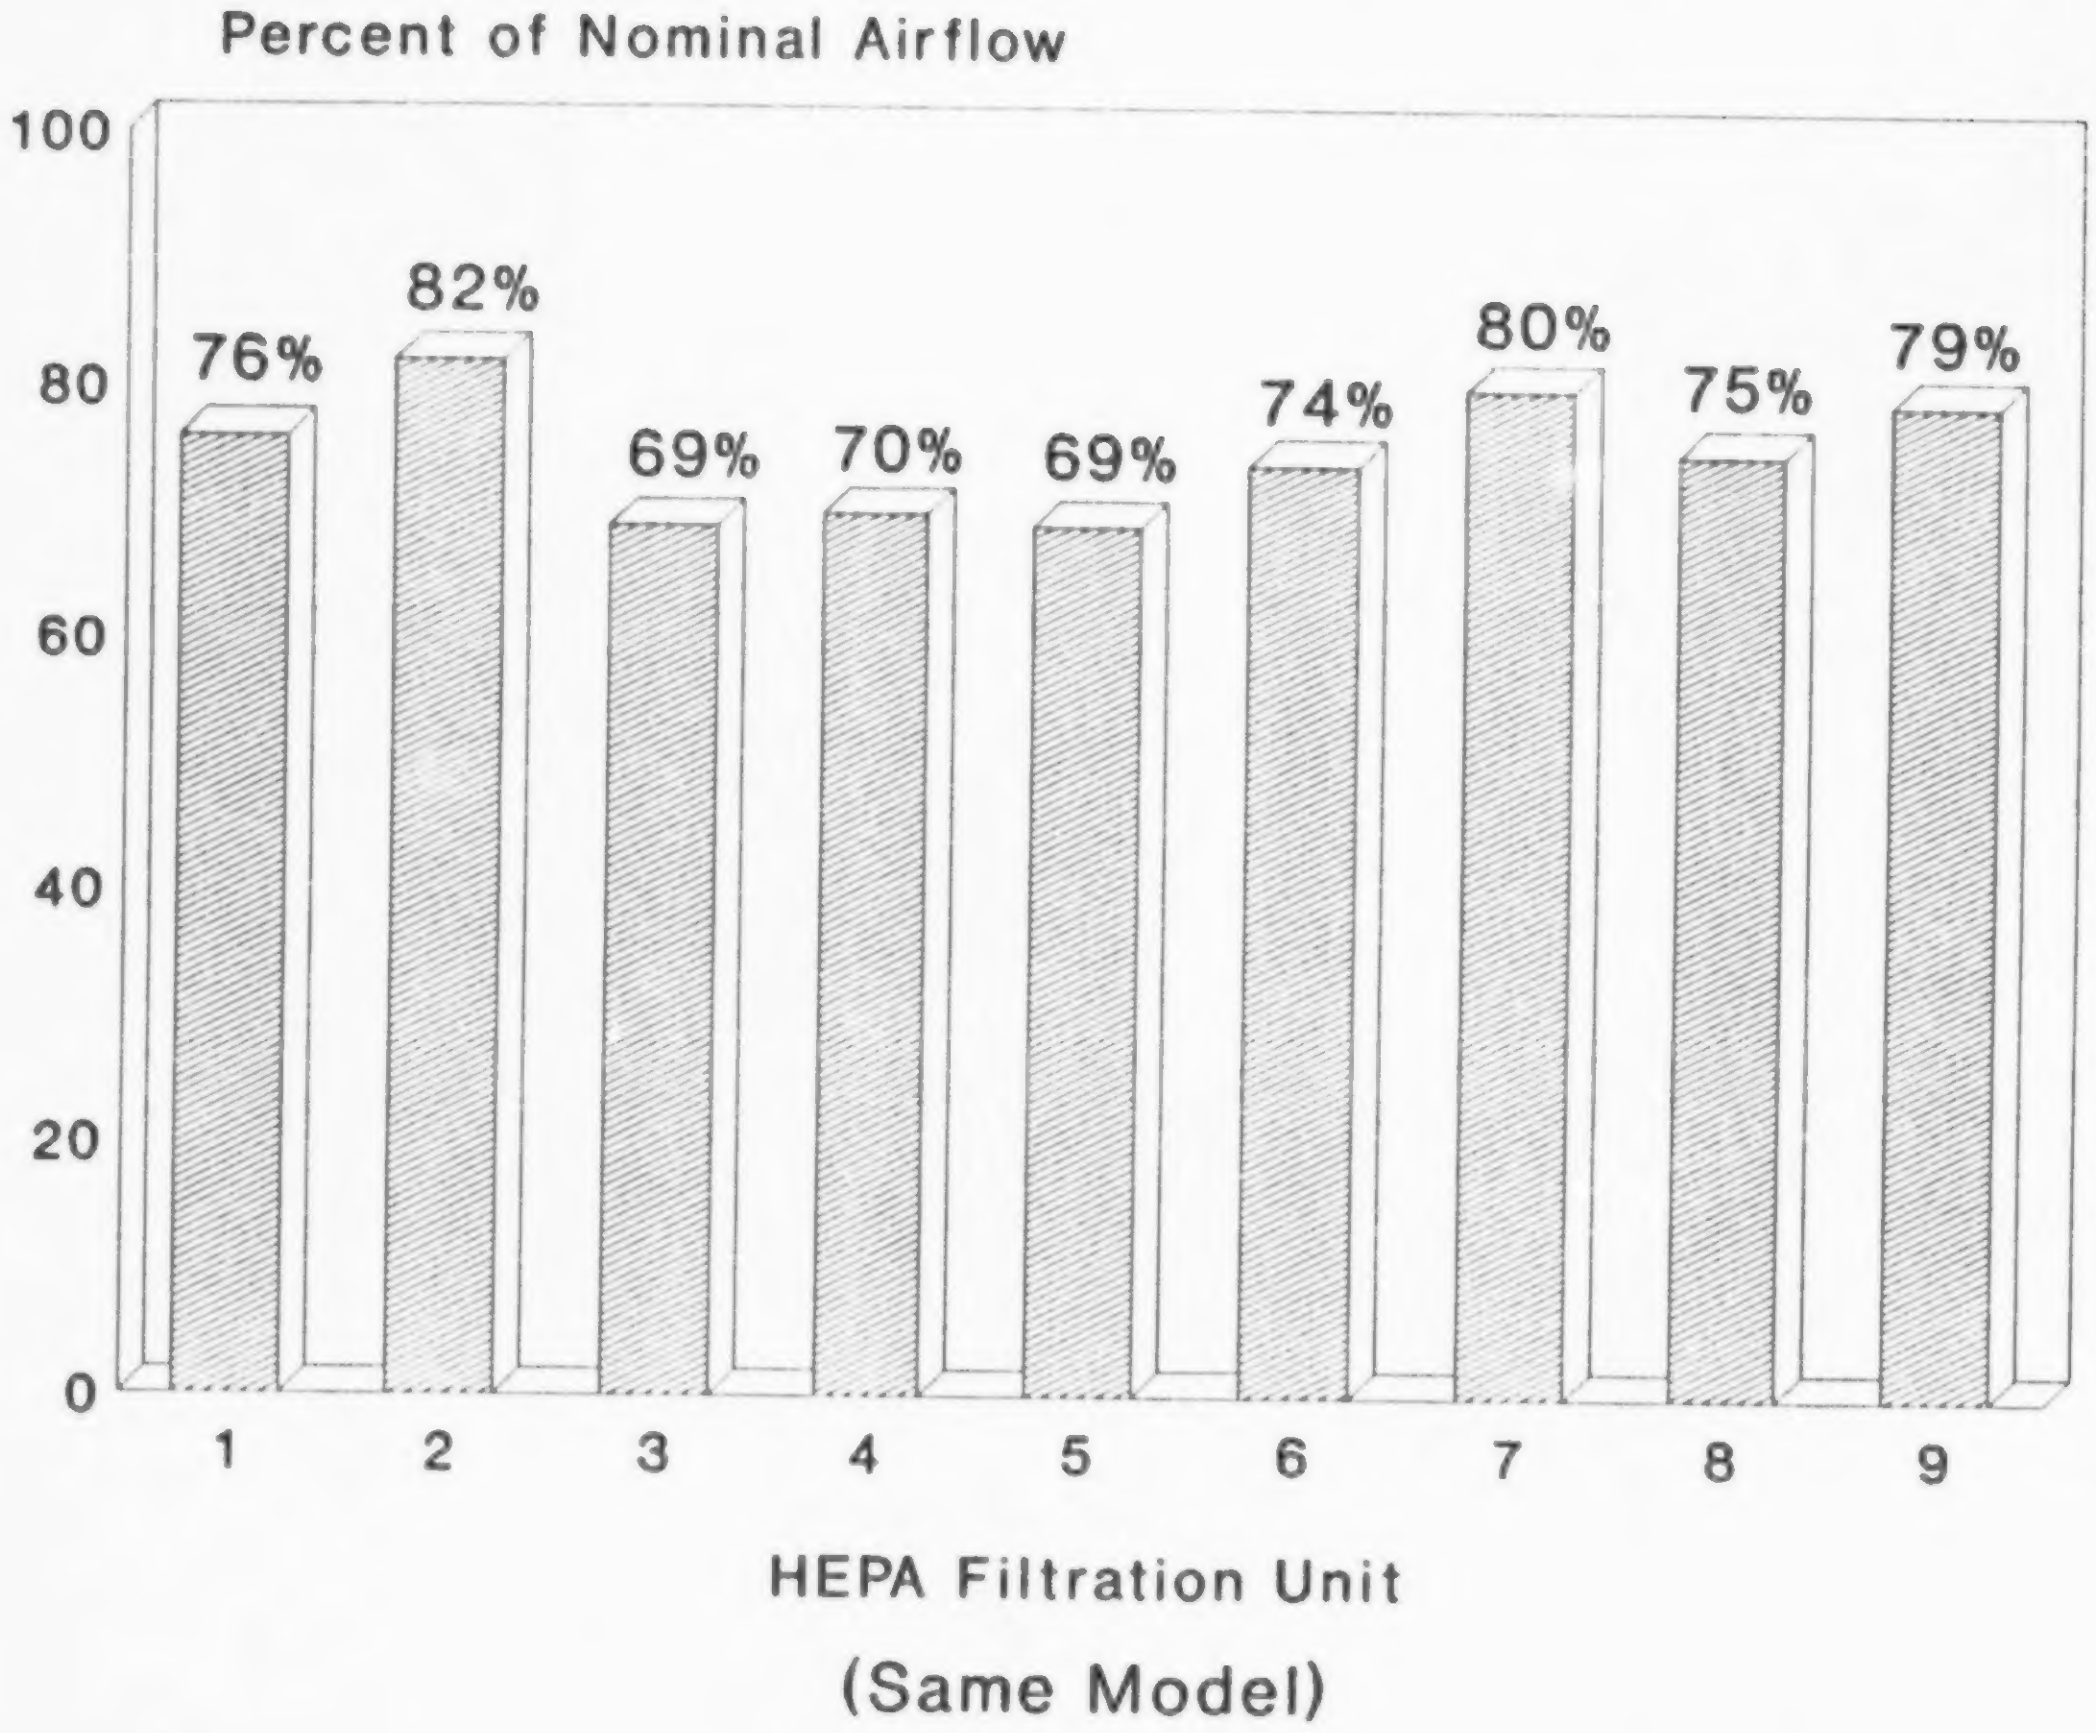
Figure R-2. Airflow performance for HEPA filtration systems operating during AHERA clearance.

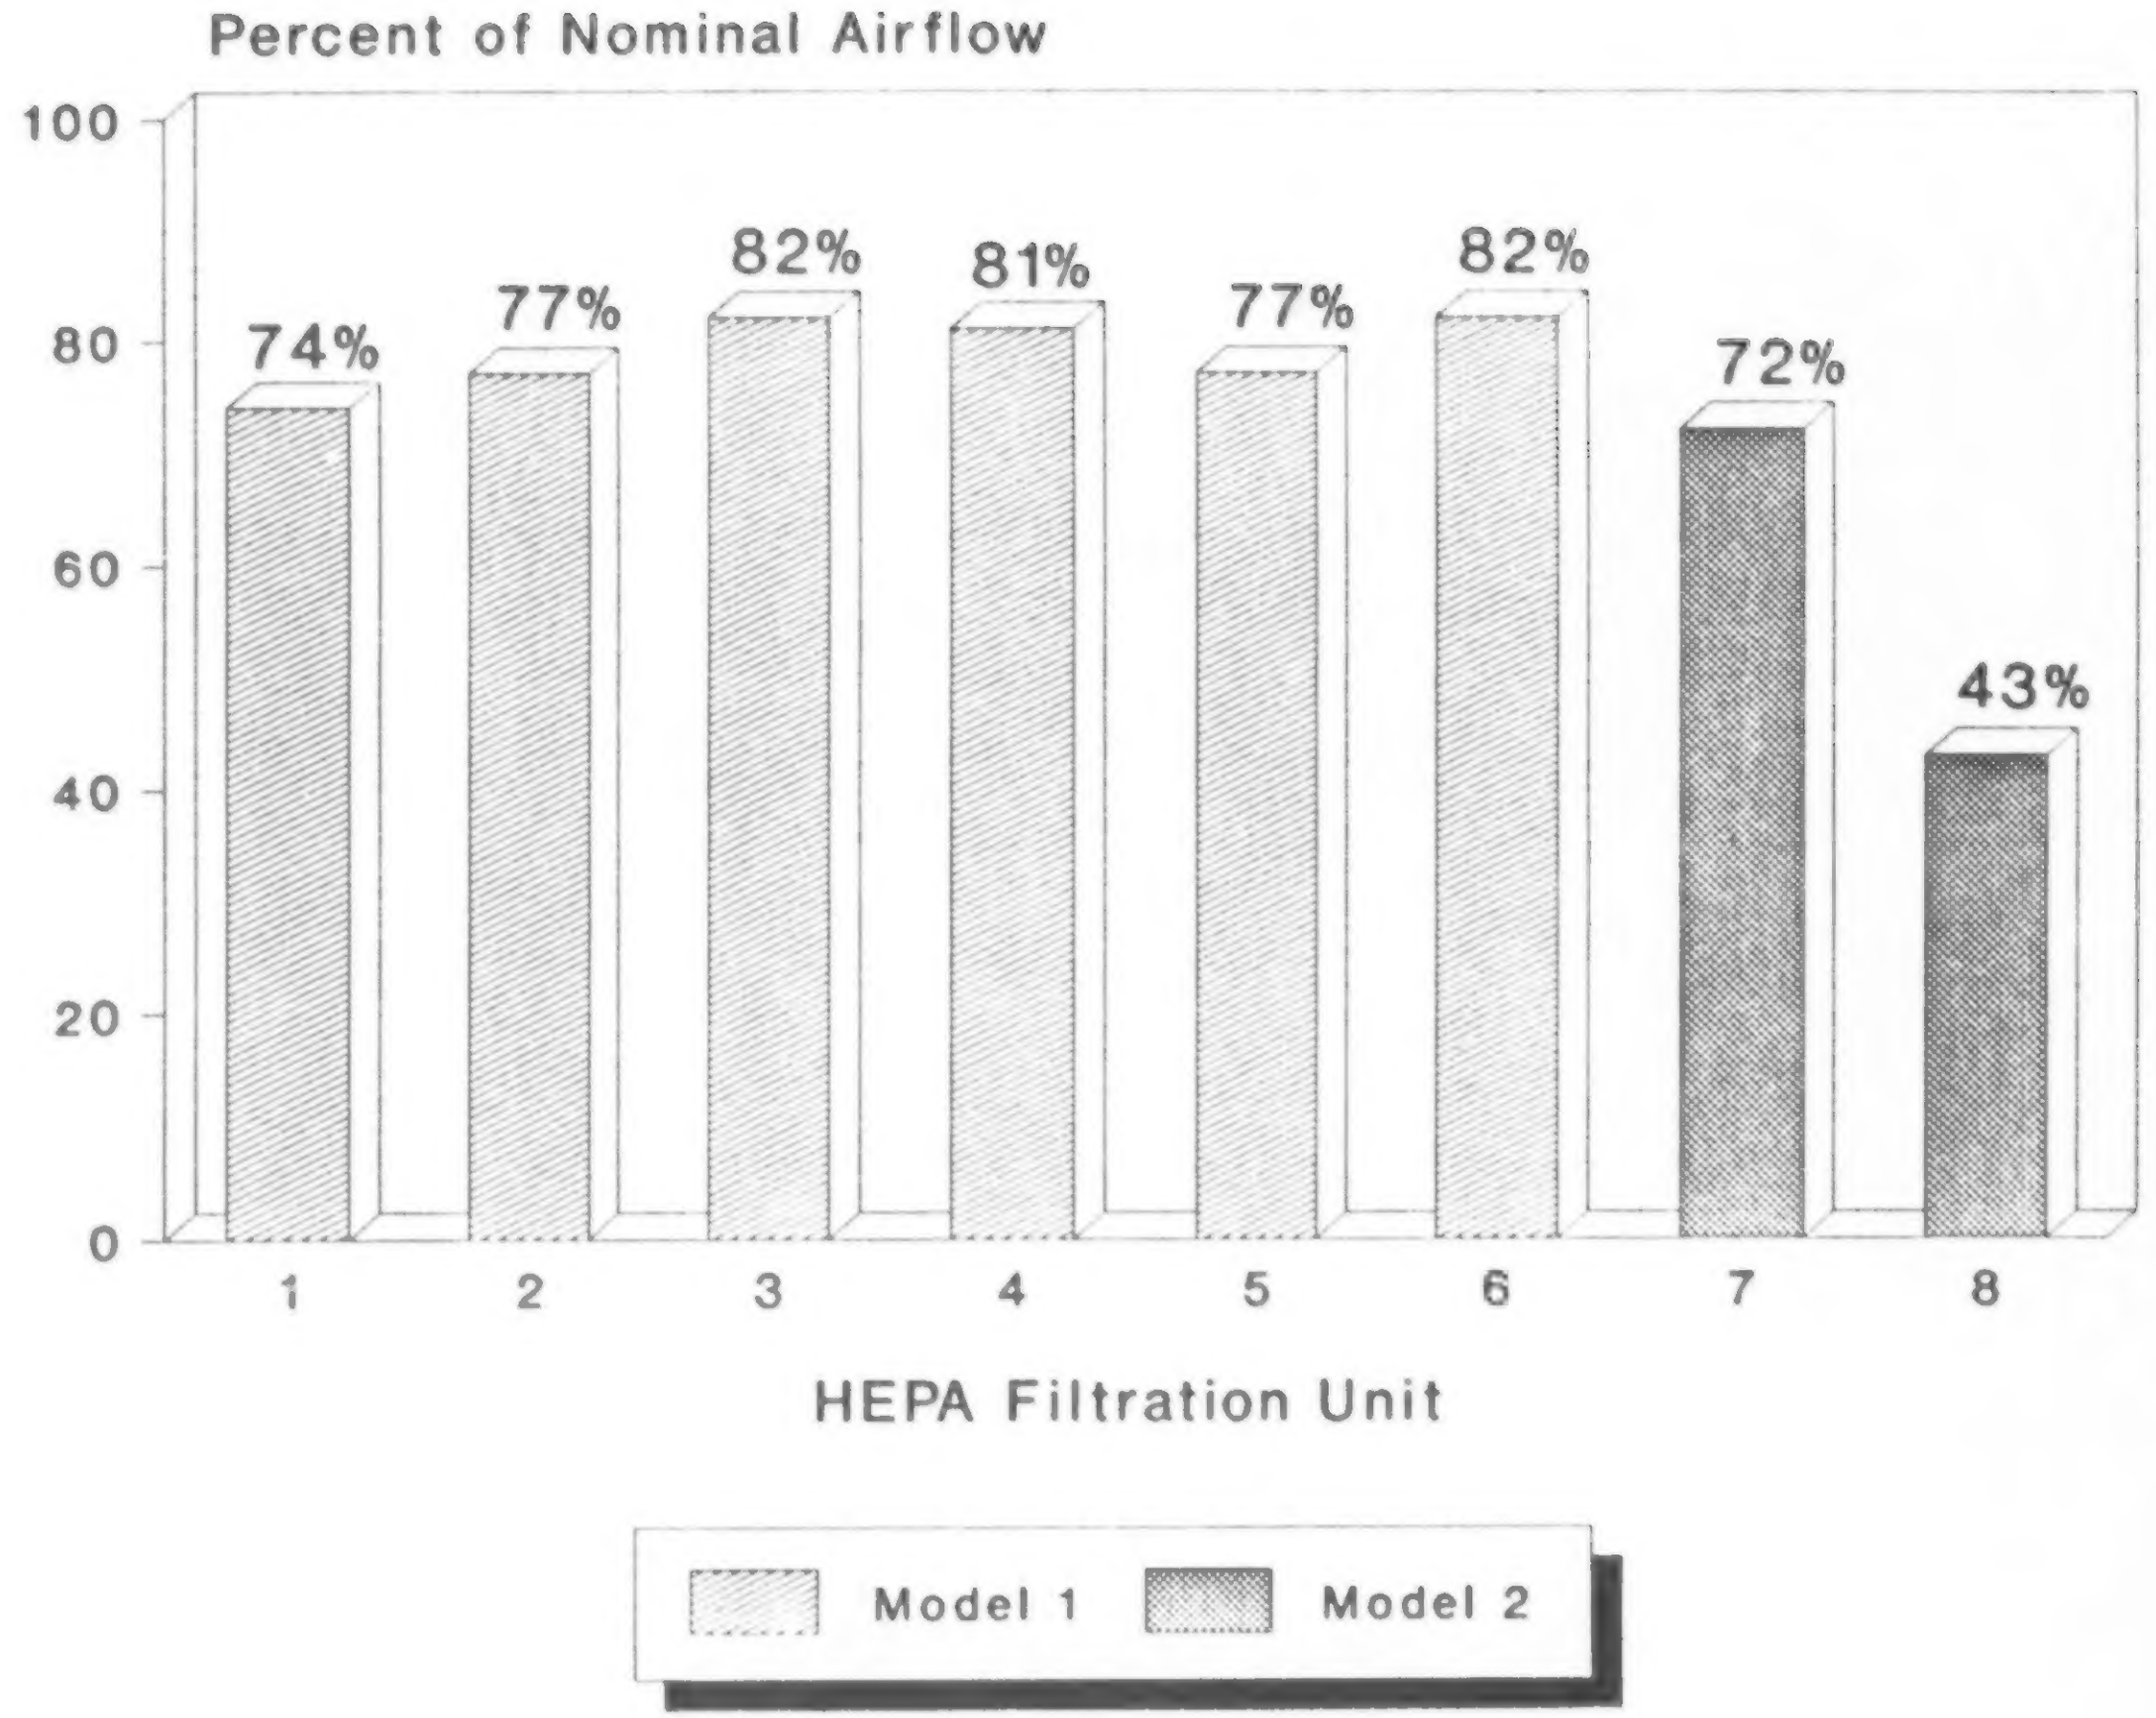
Figure S-1. Airflow performance for HEPA filtration systems operating during final cleanup.

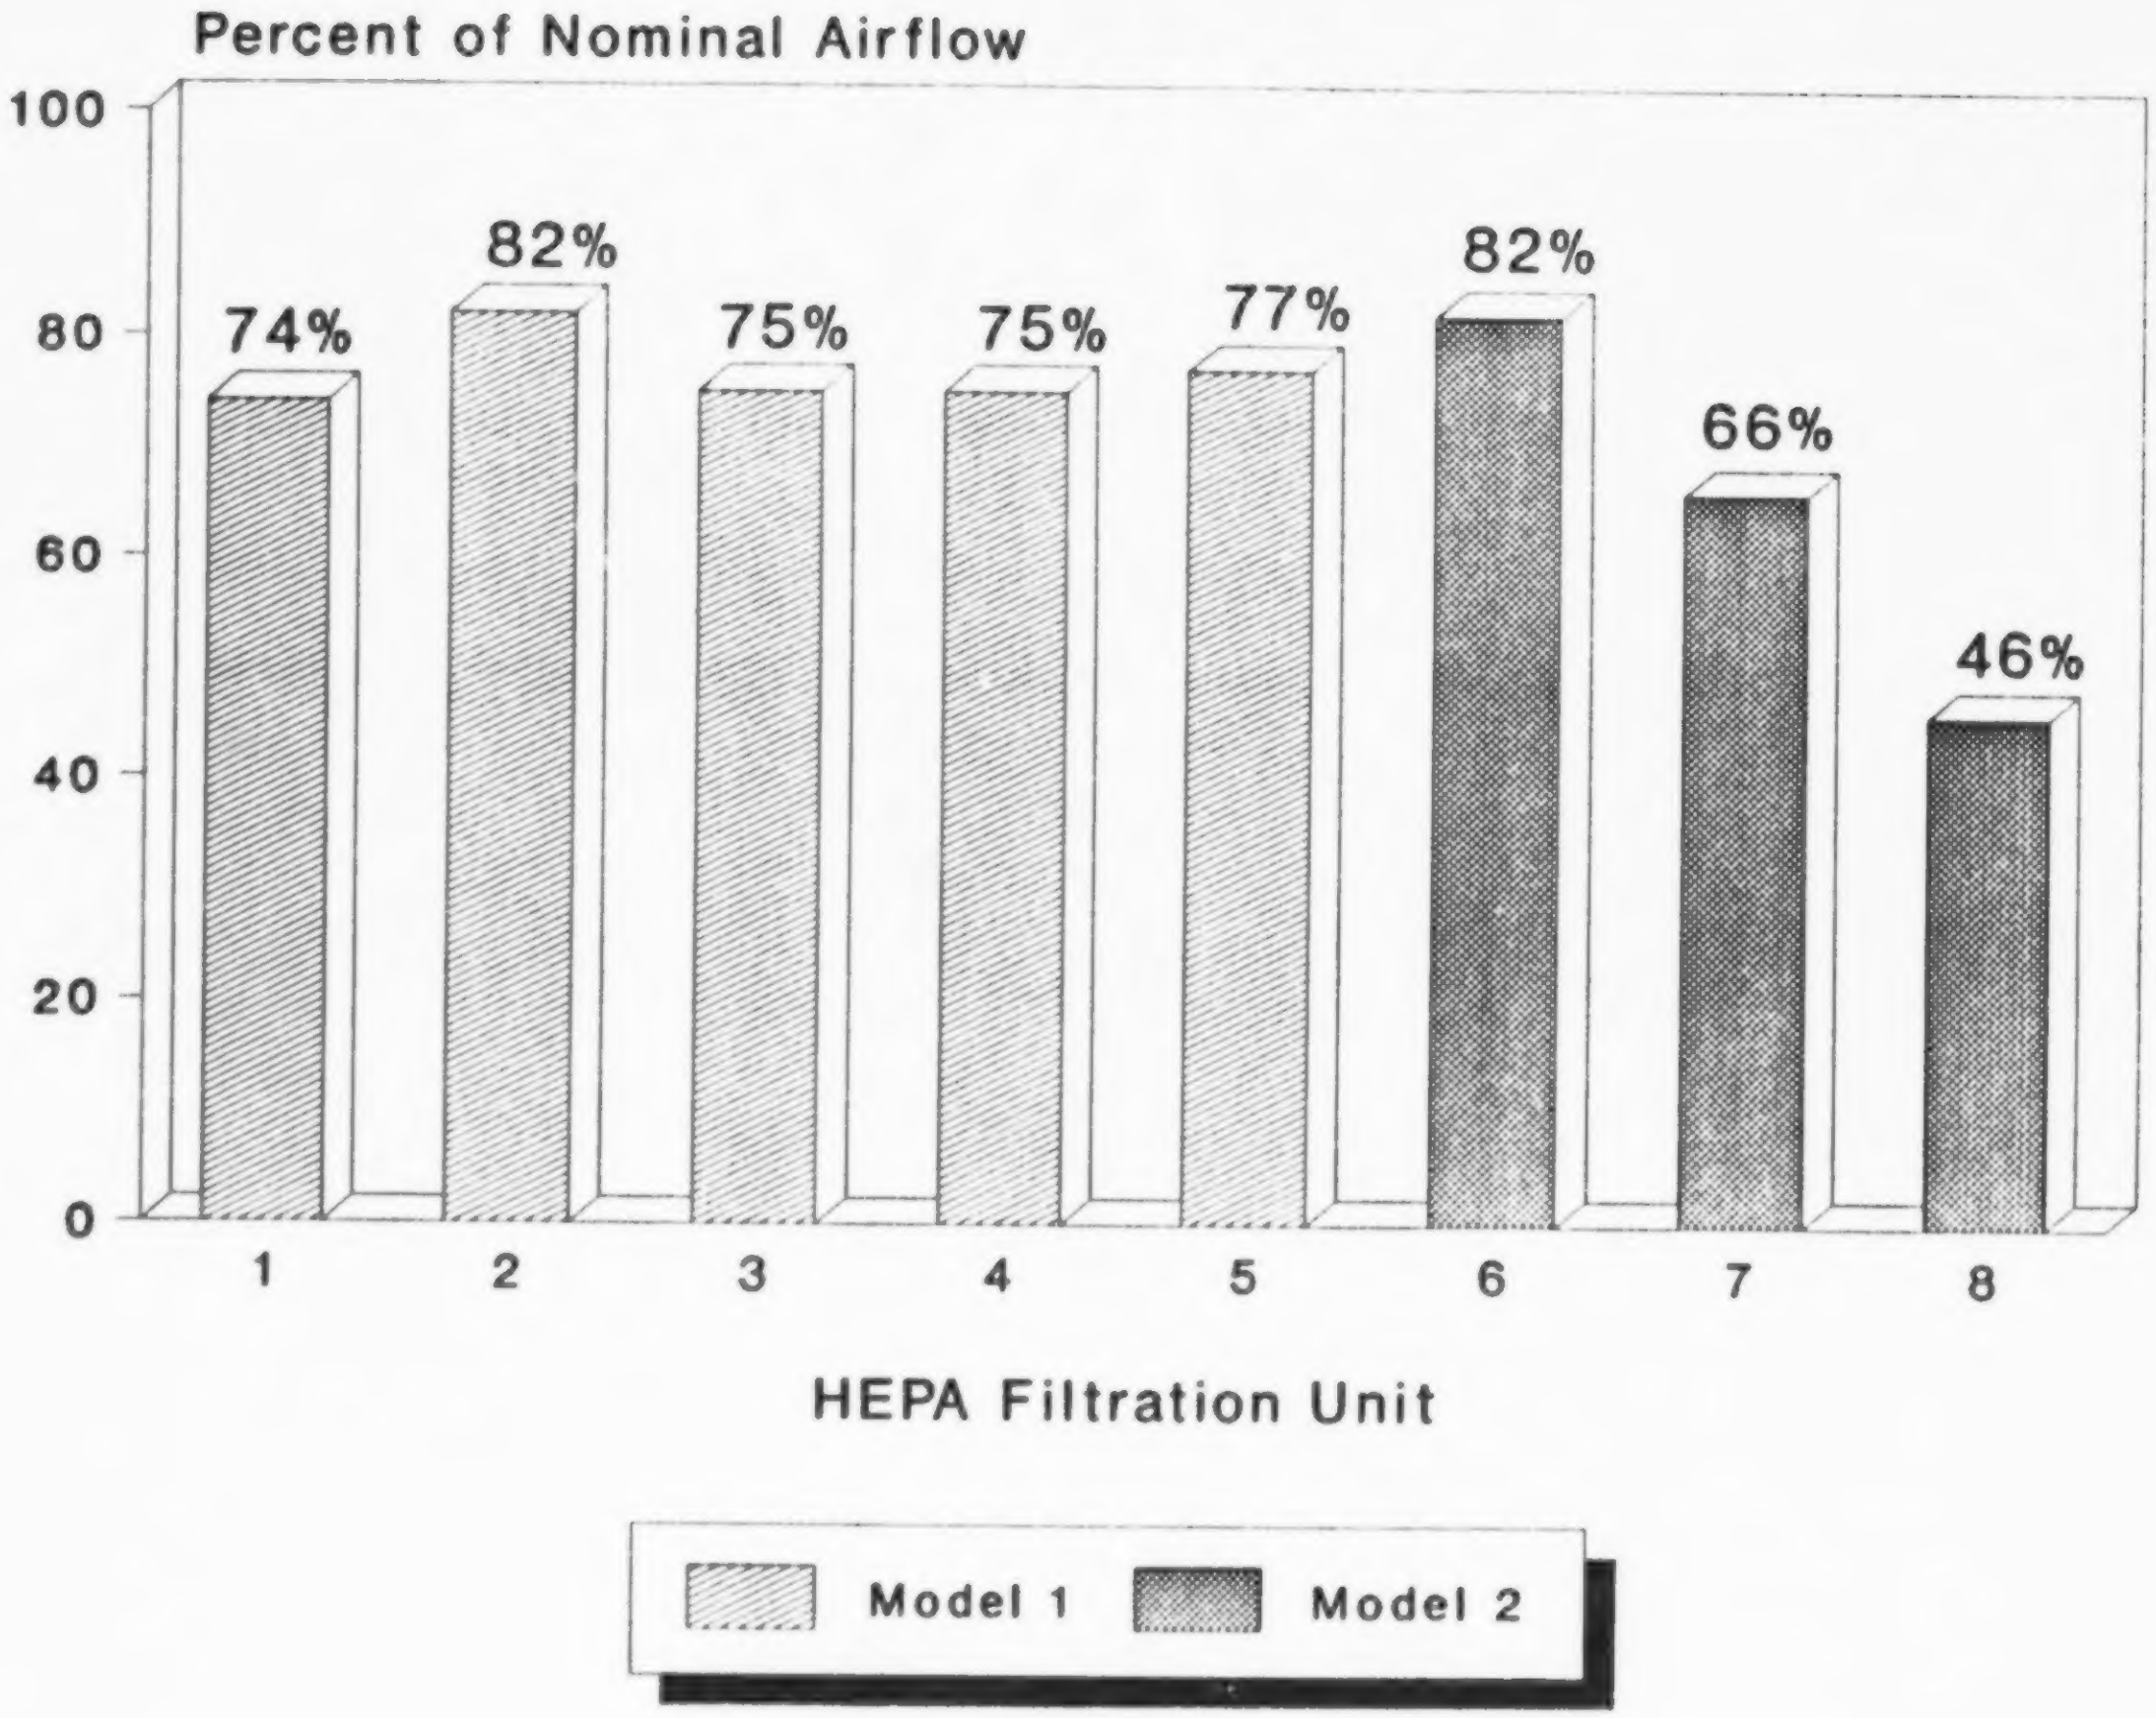
Figure S-2. Airflow performance for HEPA filtration systems operating during AHERA clearance.
